REPORT OF INVESTIGATION

**Surface Nonmetal Mine
(Limestone)**

Fatal Electrical Accident

**Adams Trucking Co., Inc.
Contractor I.D. No. 6MH
at
Specialty Minerals Inc.
Adams Mine
Adams, Berkshire County, Massachusetts
Mine I.D. No. 19-00035**

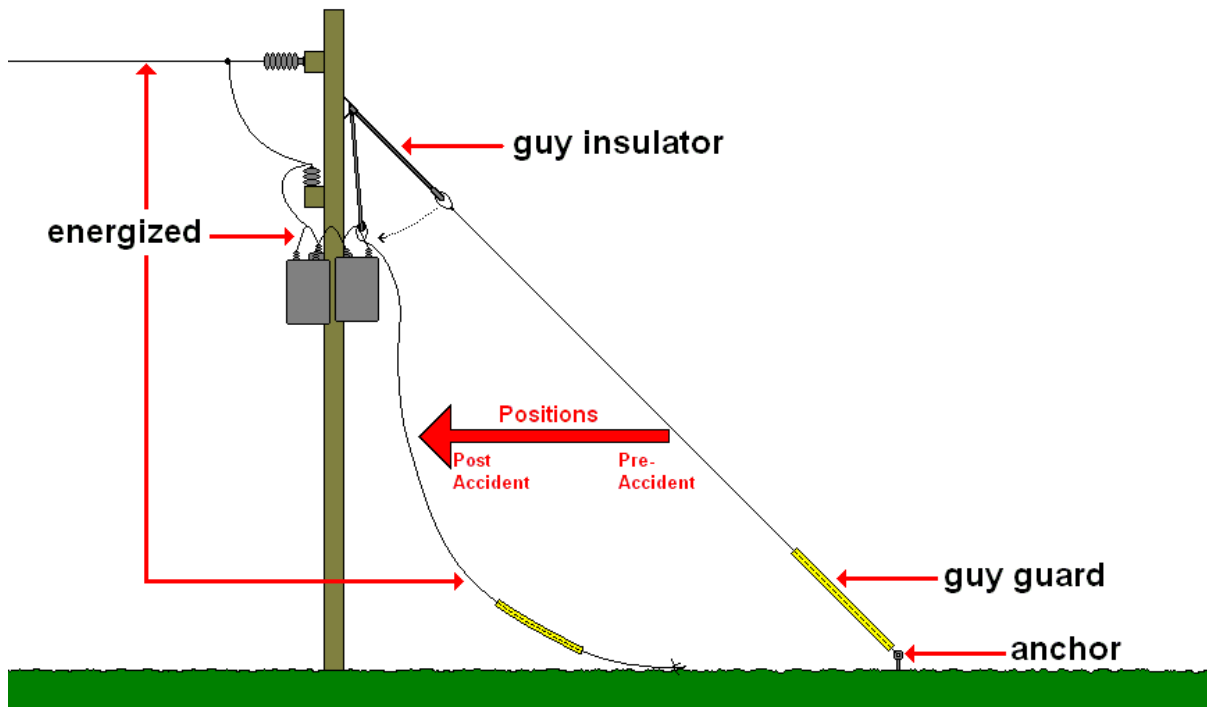
Diagram Showing Substation 15 Utility Pole

A 7.5-foot long insulator, rated at 780 kv dry and 425 kv wet, was anchored to the top of the utility pole, 37.5 feet above ground level. The bottom end of the insulator was attached to a 34-foot long galvanized steel wire which stretched to an anchor imbedded in the ground. This anchor was installed 22.5 feet from the base of the pole. (Appendix B)

Root Cause: The provided guy wire on the power pole was not installed in accordance with the National Electrical Safety Code. The guy wire was not provided with two insulators installed to include the exposed section of the guy wire between them. The slackened guy wire contacted the energized transformer supply conductor below the provided insulator, thus energizing the wire.

The accident occurred because the guy wire on the Substation 15 utility pole was not installed in accordance with the National Electrical Safety Code. The guy wire was not provided with the correct number of insulators to prevent the guy wire from becoming energized when it contacted the energized supply conductor on the utility pole.

Corrective Actions: Evaluate all electrical installations to ensure compliance with the required standards and codes. Inspect the work of independent contractors to ensure that installations and repairs to electrical systems are properly completed.
